Coastal Protection and Restoration Authority of Louisiana

2007/2008 Annual Inspection Report

EAST MUD LAKE MARSH MANAGEMENT PROJECT (CS-20)

State Project Number CS-20
Priority Project List 2

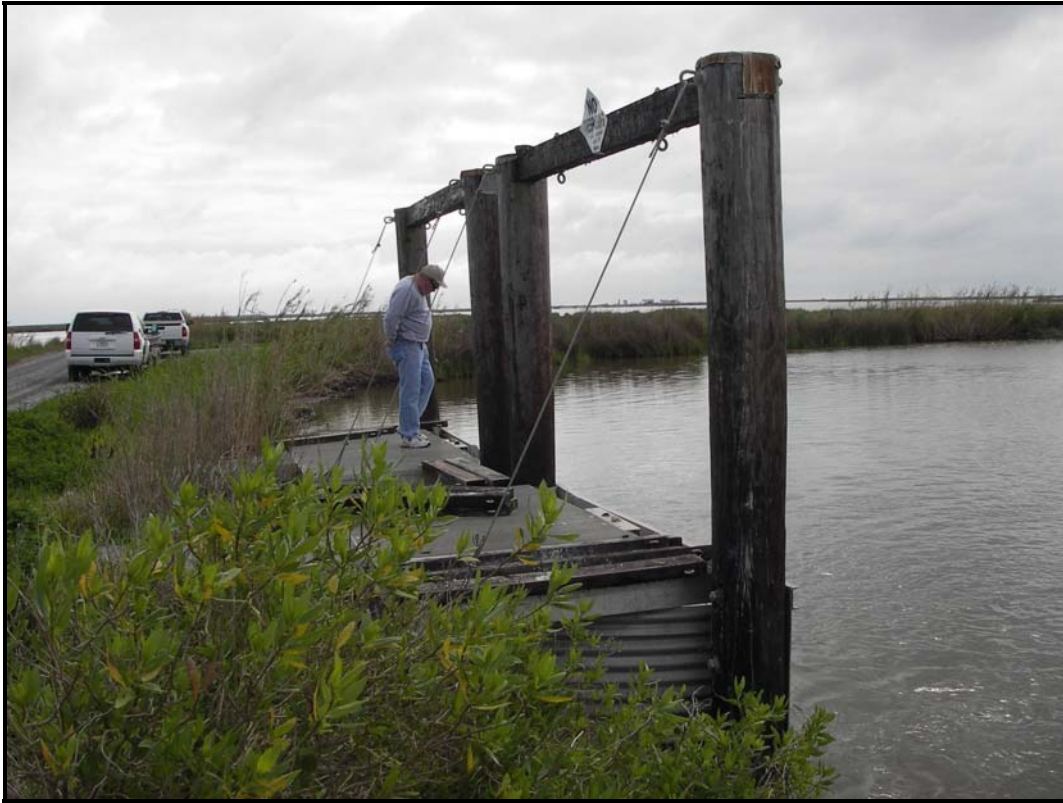
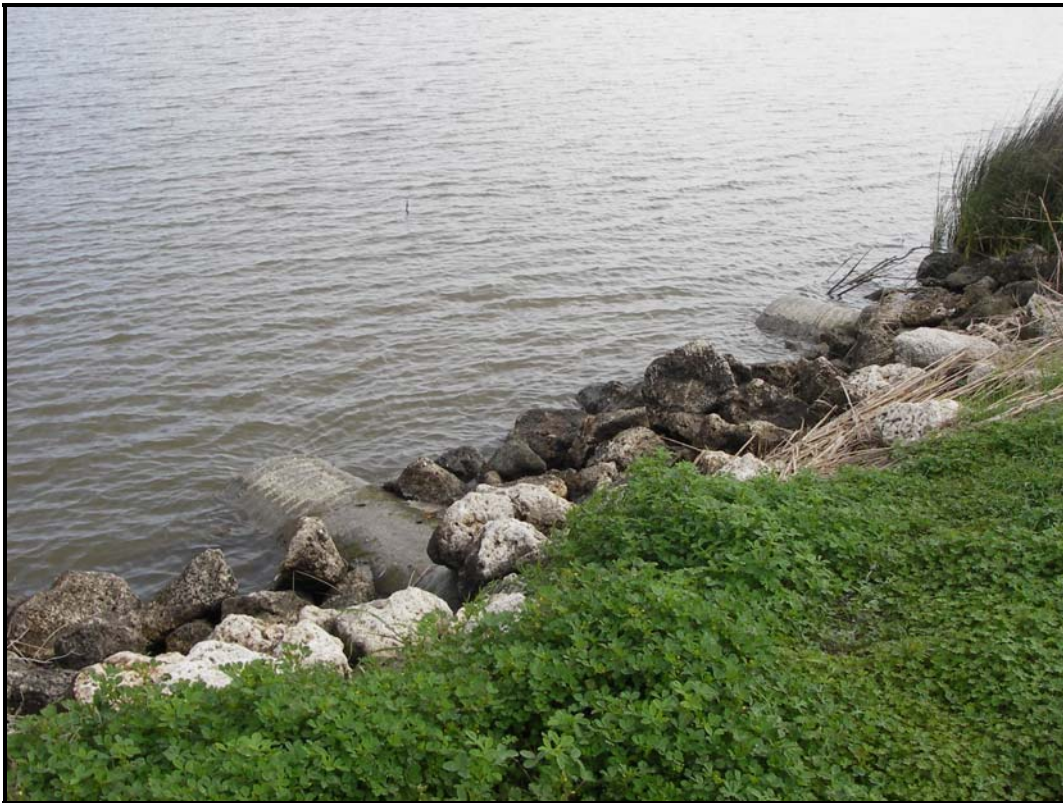
The overall condition of Structure No. 6 appears to be very good. Water level gauges weren't available near the structure. Water was flowing into the project at the time of the inspection. The timber piles, stop logs, grating, etc. are in good condition, however the metal pile caps are

rusting out. Rock placed around the outlet side of the structure has held up well and stabilized the shoreline. Erosion is occurring on the bank line adjacent to the inlet side of the structure. The ends of the outlet pipes are clogged with marsh and other debris. The padlocks on the stop log locking devices have rusted and cannot be operated. As a result of the inspection of Structure No. 6, LDNR and NRCS agree that approximately 114 tons of stone needs to be added on the cut bank lines adjacent to the access roadway, replace padlocks, replace lock pins, replace metal pile caps, and clean out ends of both outfall pipes of marsh debris. (Photos: Appendix B, Photos 1 & 2).

Photo 1, Structure No. 6, view looking southeast.

Photo 2, Structure No.6, showing outlet pipes.

Item	Condition	Physical Damage	Corrosion	Photo #	Observations and Remarks
Steel Bulkhead / Caps	N/A				
Steel Grating	Good				
Stop Logs	Good				
Hardware	Poor		Yes	1	Corrosion on padlocks, need to be replaced.
Timber Piles	Good				
Timber Wales	Good				
Galv. Pile Caps	Poor		Yes	1	Need to be replaced.
Cables	Good				
Signage / Supports	Fair				General Note: There are no staff gages at this structure.
Outlet Pipes	Fair			2	The ends of both outlet pipes are clogged with marsh debris.
Earthen Embankment	Fair			1	Rock armor needed on bank line adjacent to inlet structure.

- ES-6 – rock rip rap for bank erosion, replace padlocks and metal pile caps, clean out culverts.
- ES-7 – rock rip rap for bank erosion, replace padlocks and metal pile caps, check elevation of staff gages, clean out culverts.

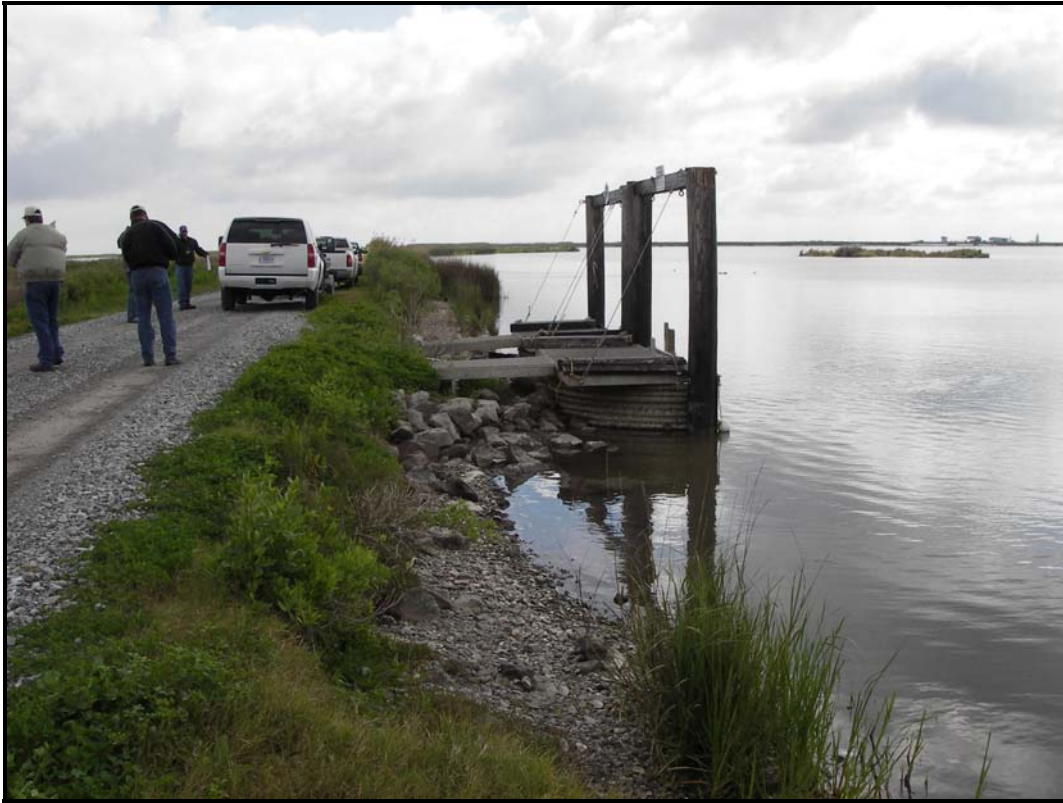
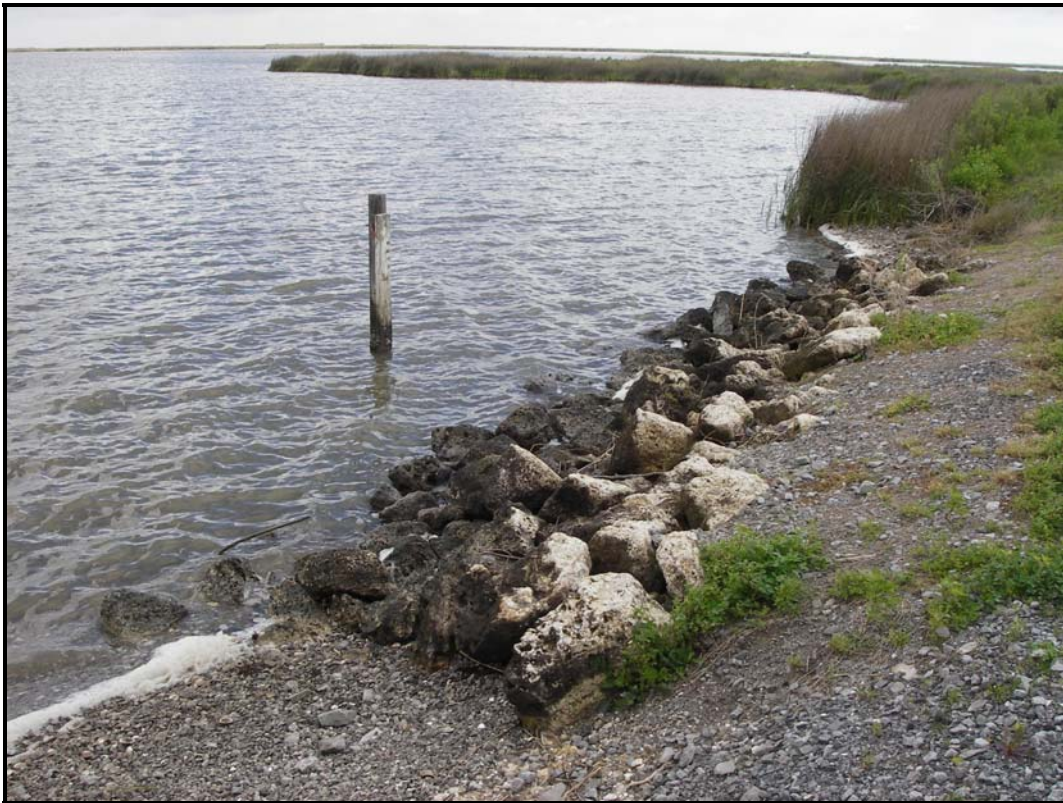
Structure No. 7 appears to be in very good condition. Water level gage on the inside was +0.9 NAVD88 and the outside gage was slightly above +0.9 NAVD88. (Note: these staff gages were recently replaced through the CRMS program). Both ends of this structure are clogged with marsh debris and have silted up. Erosion is occurring on the bank line adjacent to the inlet side of the structure. The padlocks on the stop log locking devices have rusted and cannot be operated. As a result of the inspection of Structure No. 7, LDNR and NRCS agree that approximately 66 tons of stone needs to be added on the cut bank lines adjacent to the access roadway, replace padlocks, replace lock pins, replace metal pile caps, check elevation of staff gages on inlet and outlet side of the structure, and clean out ends of both outfall pipes of marsh debris. (Photos: Appendix B, Photos 3 & 4).

Photo 3, Structure No.7, view looking east and showing bank line erosion.

Photo 4, Structure 7, outlet pipe location, however pipes not visible.

Item	Condition	Physical Damage	Corrosion	Photo #	Observations and Remarks
Steel Bulkhead / Caps	N/A				
Steel Grating	Good				
Stop Logs	Good				
Hardware	Poor		Yes	3	Corrosion on padlocks, need to be replaced.
Timber Piles	Good				
Timber Wales	Good				
Galv. Pile Caps	Poor		Yes	3	Need to be replaced.
Cables	Good				
Signage / Supports	Good				
Staff Gages	Good				Need to check elevation of staff gages both inside and outside.
Inlet/Outlet Pipe	Fair			4	Inlet and outlet pipes are clogged with marsh debris.
Earthen Embankment	Fair			3	Rock armor needed on bank line adjacent to inlet structure.

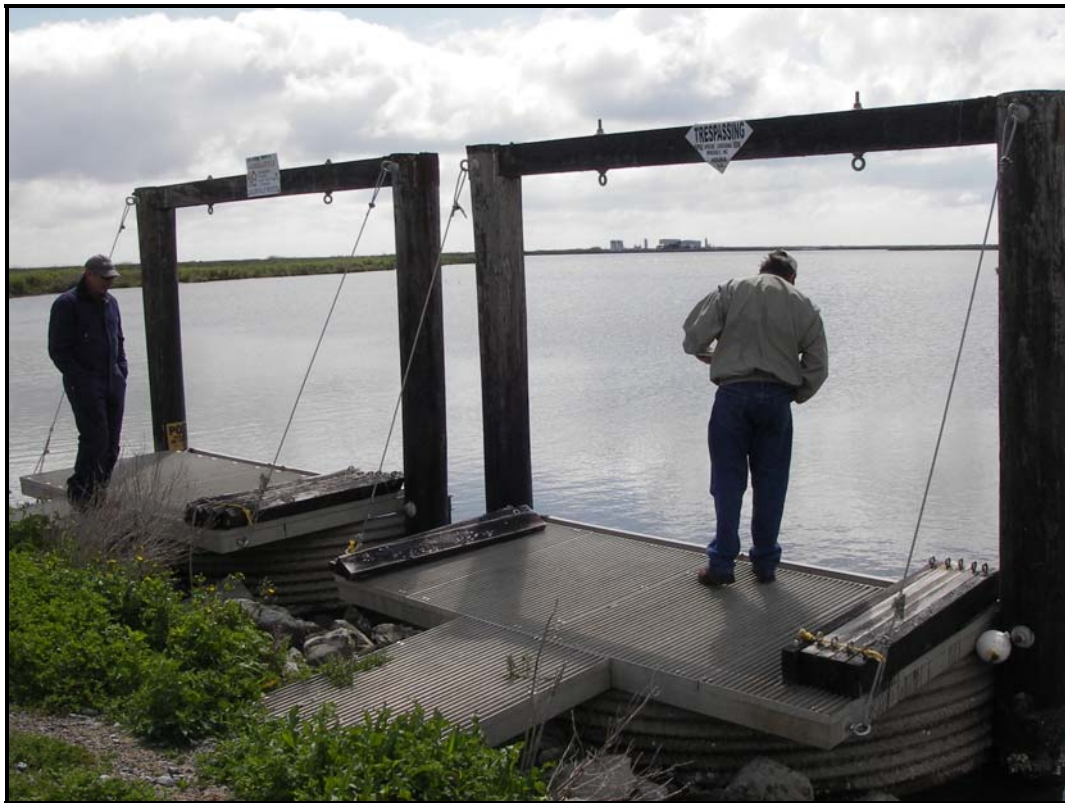
Structure No. 8 appears to be in very good condition. Water level gauges were unavailable. Both ends of this structure are clogged with marsh debris and have silted up. It appears very little flow is going through the pipes due to washover of the access road rock material into the water. Erosion is occurring on the bank line adjacent to the inlet side of the structure. The padlocks on the stop log locking devices have rusted and cannot be operated. LDNR and NRCS agree that this structure requires clean out of the ends of outlet pipes, placement of approximately 66 tons of rock along cut bank lines adjacent to the structure, replace padlocks, replace lock pins, and replace metal pile caps. (Photos: Appendix B, Photo 5).

Photo 5, Structure 8, view looking southwest.

Item	Condition	Physical Damage	Corrosion	Photo #	Observations and Remarks
Steel Bulkhead / Caps	N/A				
Steel Grating	Good				
Stop Logs	Good				
Hardware	Poor		Yes	5	Corrosion on padlocks, need to be replaced.
Timber Piles	Good				
Timber Wales	Good				
Galv. Pile Caps	Poor		Yes	5	Need to be replaced.
Cables	Good				
Signage / Supports	Good				
Staff Gages					Note: There are no staff gages inside and outside of this structure.
Inlet/Outlet Pipe	Fair				
Earthen Embankment	Fair			5	Rock armor needed along bank line adjacent to inlet structure.

- ES-8 – rock rip rap for bank erosion, replace padlocks and metal pile caps.
- ES-9a – replace metal pile caps, clean out culvert, check elevation of staff gages, replace padlocks and repair flapgate handle.

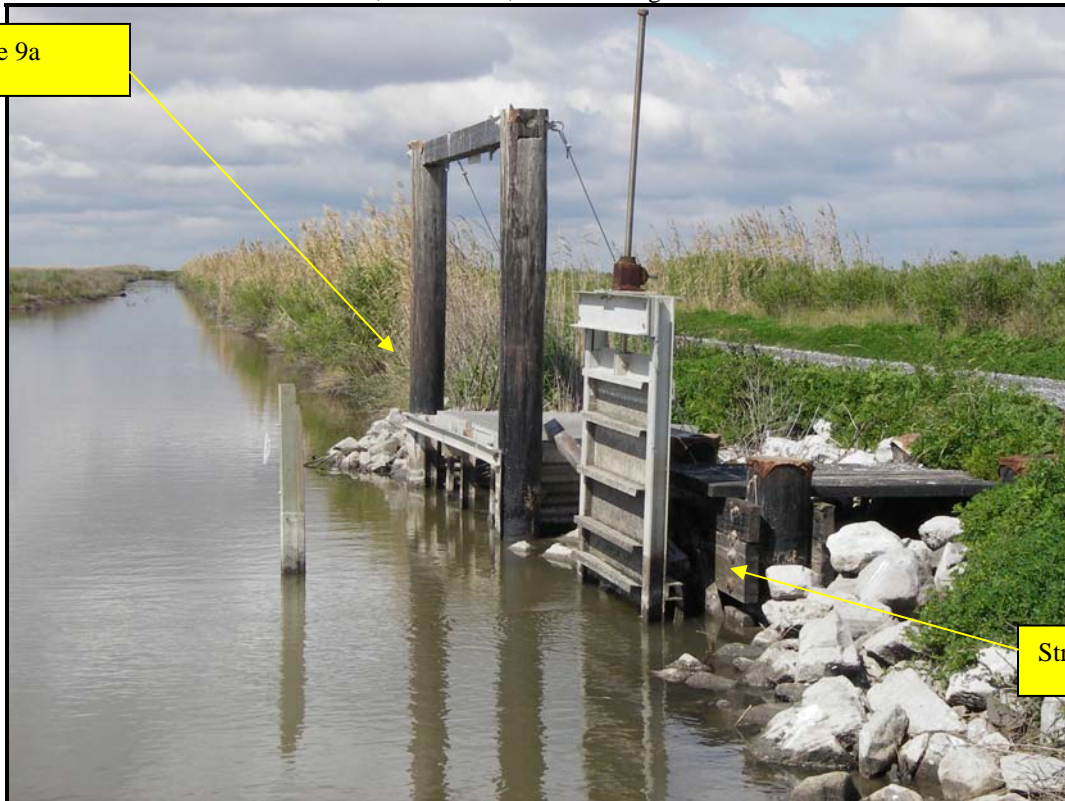
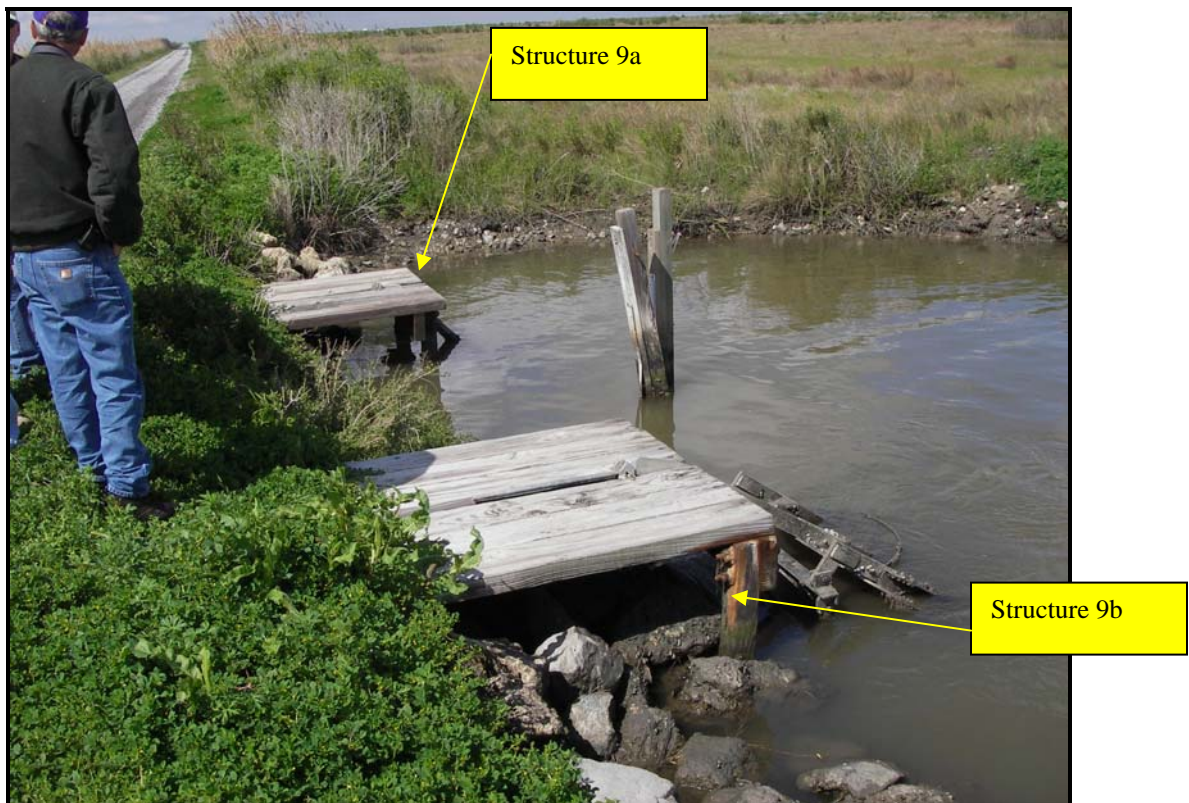
Structure No. 9a is in good condition. The staff gage on the inside was slightly above +0.7 NAVD88 and the gage on the outside was +0.7 NAVD88. (Note: these staff gages were recently replaced through the CRMS program). Both ends of this structure are clogged with marsh debris and have silted up. The handle on the outlet pipe flapgate has been broken off. The metal pile caps on the pilings have rusted out. The padlocks on the stop log locking devices have rusted and cannot be operated. LDNR and NRCS agree that this structure requires replacement of the metal pile caps, clean out of the ends of outlet pipes, check elevation of staff gages inside and out, replace padlocks, replace lock pins and repair of the flapgate handle. (Photos: Appendix B, Photos 6 & 7).

Structure No. 9b is in good condition. Both ends of this structure are clogged with marsh debris and have silted up. The staff gage on the inside was slightly above +0.7 NAVD88 and the gage on the outside was +0.7 NAVD88. (Note: these staff gages were recently replaced through the CRMS program). Water was flowing out to the exterior marsh. The handle on the outlet pipe flapgate has been broken off. The gear box on the sluice gate is showing signs of rust and the stem cover is missing. Apache personnel have reported that it, so far, is not a problem; however it will probably need to be addressed. Metal pile cap covers have rusted out. The seat flange on the flap gate is broken and has come apart from the pipe barrel. LDNR and NRCS agree that this structure is in operable condition and maintenance will be required to refurbish the gear box and replace stem cover, replace seat flange on flap gate, clean out of the ends of outlet pipes, replace padlocks, replace metal pile caps and repair flapgate handle. (Photos: Appendix B, Photos 6, 7 & 8).

Photo 6, Structure No. 9a & 9b, view looking west.

Photo 7, Structure No. 9a & 9b, showing outlet pipe flap gates.

Item	Condition	Physical Damage	Corrosion	Photo #	Observations and Remarks
Steel Bulkhead / Caps	N/A				
Steel Grating	Good				
Stop Logs	Good				
Hardware	Fair		Yes	6,7,8	Corrosion on padlocks, handles on outlet pipe flap gates are broken.
Sluice Gate	Poor		Yes	8	Gear box corroded and needs to be refurbished, stem cover missing, needs to be replaced.
Timber Piles	Good				
Timber Wales	Good				
Galv. Pile Caps	Poor		Yes	6	Need to be replaced.
Cables	Good				
Signage / Supports	Good				
Staff Gages	Good			6,7	Check elevation of staff gages inside and out.
Rip Rap (fill)	Good				
Earthen Embankment	Good

- ES-9b – refurbish gear box and replace stem cover, replace seat flange on flapgate, clean out culvert, replace padlocks and metal pile cap covers, repair flapgate handle.

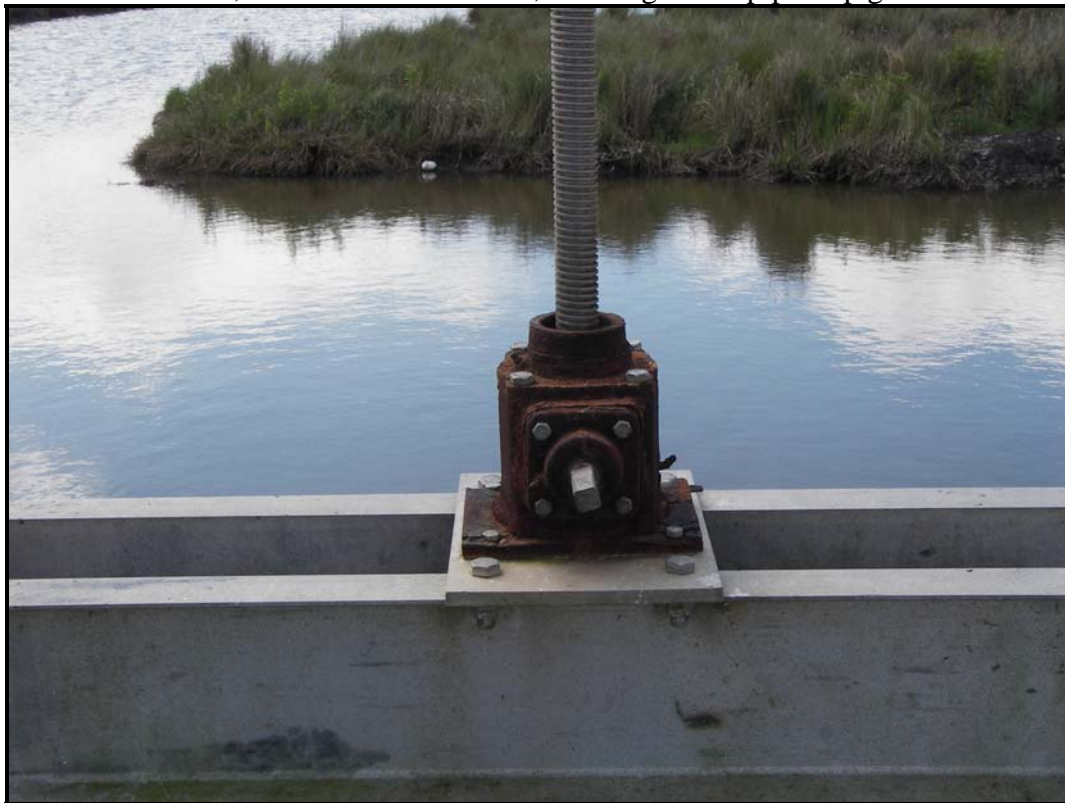
Photo 8, Structure No. 9b, showing corrosion on gear box & missing stem cover.

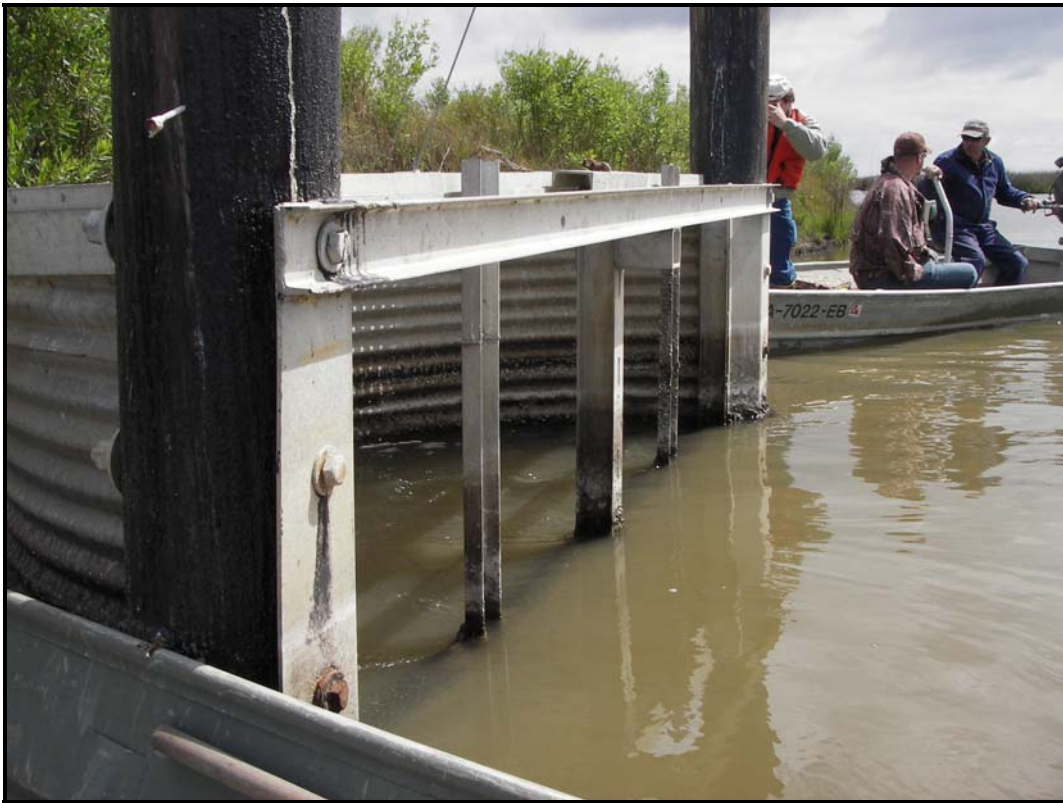
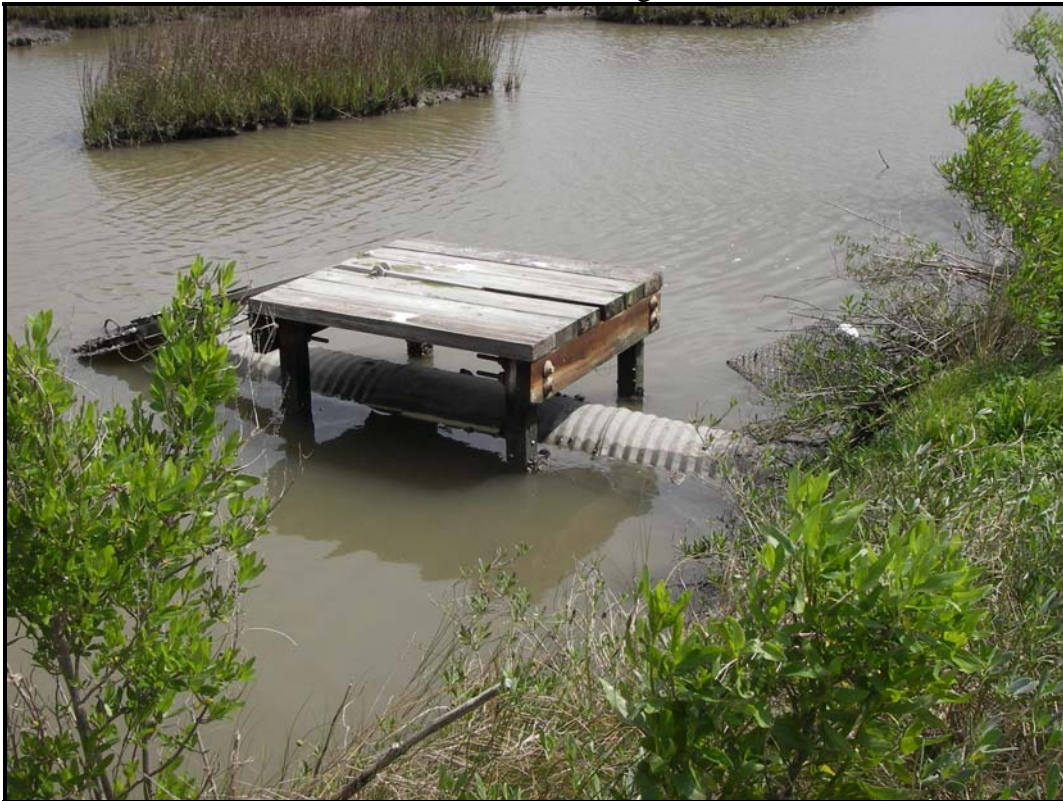
The structure is in good condition. Water level on the outside staff gage was +0.7 NAVD88 and the gage on the inside was +0.8 NAVD88. (Note: these staff gages were recently replaced through the CRMS program). Water was flowing out to the exterior marsh. There is some erosion of the bank on both the inlet and discharge sides of the structure. Approximately 228 tons of man size rip rap will be required to reinforce the bank around the structure. The bank line near the outlet flap gate has eroded and the boardwalk is not accessible. The metal pile cap covers have rusted out. The padlocks on the stop log locking devices have rusted and cannot be operated. LDNR and NRCS agree that maintenance work is required to add rip rap on both sides of the structure, extend wooden boardwalk, replace metal pile caps, replace padlocks, replace lock pins and check elevations of replaced staff gages inside and out. (Photos: Appendix B, Photos 9 & 10).

Photo 9, Structure No. 11, view showing inlet side of structure.

Photo 10, Structure No.11, outlet pipe and flap gate.

Item	Condition	Physical Damage	Corrosion	Photo #	Observations and Remarks
Steel Bulkhead / Caps	N/A				
Steel Grating	Good				
Stop Logs	Good				
Hardware	Poor		Yes	9	Corrosion on padlocks, need to be replaced.
Timber Piles	Good				
Timber Walkway	Poor			10	Wooden boardwalk needs to be extended.
Timber Wales	Good				
Galv. Pile Caps	Good				
Cables	Good				
Signage / Supports	Fair				
Staff Gages	Good			9,10	Check elevation of staff gages inside and out.
Rip Rap (fill)	N/A				
Earthen Embankment	Fair	Yes		9,10	Rock armor needed on both sides of the structure.

- ES-11 – rock rip rap for bank erosion, extend boardwalk, replace metal pile cap covers and padlocks, check elevation of staff gages.
- ES-5 – rock rip rap for bank erosion, replace metal pile cap covers, replace padlocks, replace boardwalk, and check elevation of staff gages.

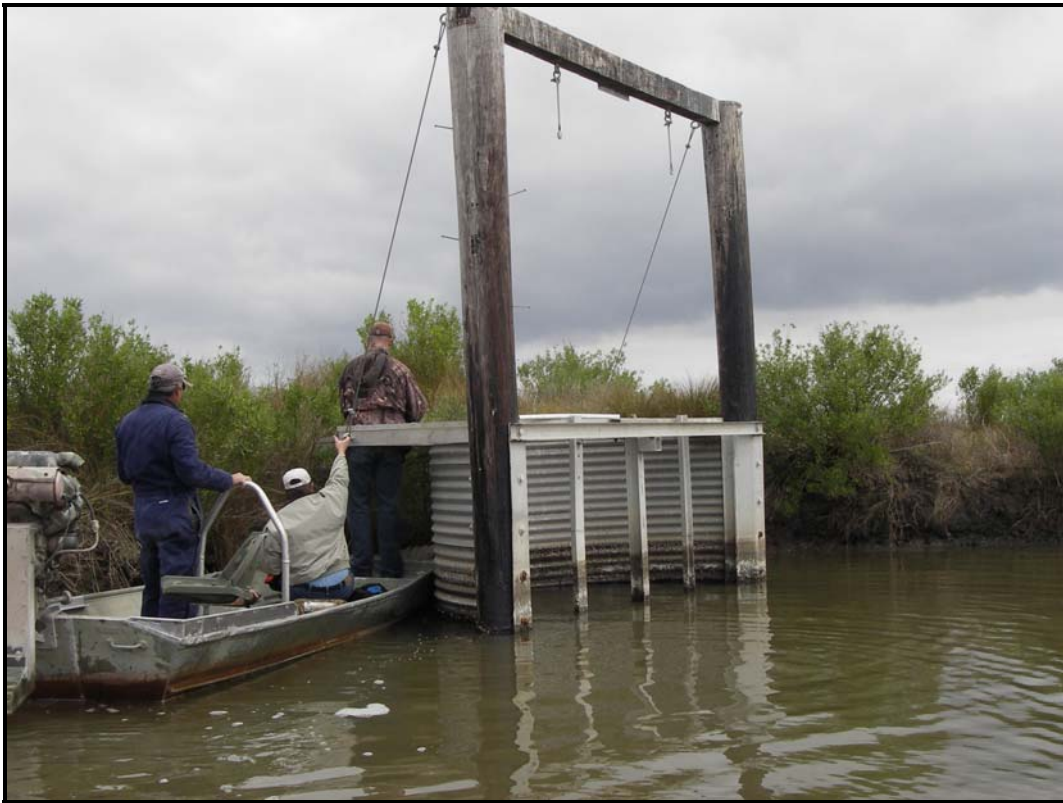
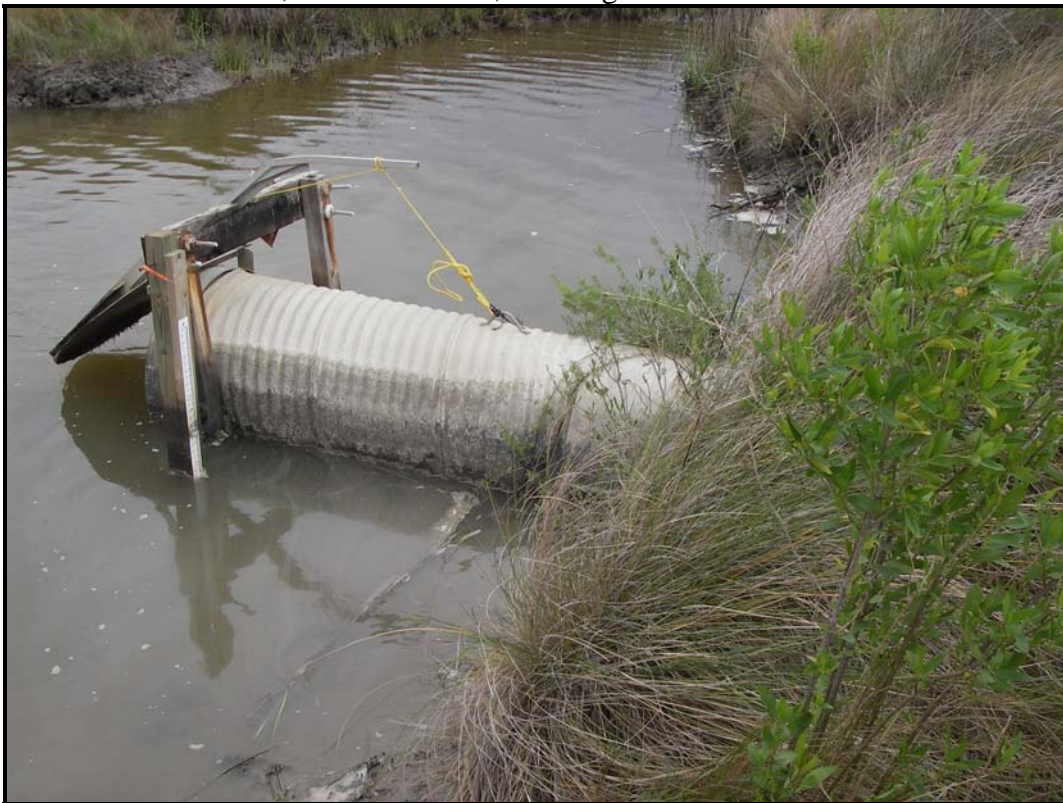
The structure itself is in good condition. Water level on the outside staff gage was +0.8 NAVD88 and the gage on the inside was slightly above +0.8 NAVD88. (Note: these staff gages were recently replaced through the CRMS program). Water was flowing out to the exterior marsh. Erosion was noted along the bank on both the inlet and discharge sides of the structure. Approximately 342 tons of rock will be needed to reinforce the bank around this structure. The boardwalk at the outlet pipe flap gate is missing. The metal pile cap covers have rusted out. The padlocks on the stop log locking devices have rusted and cannot be operated. LDNR and NRCS agree that maintenance work is required to add rip rap, replace metal pile caps, replace padlocks, replace lock pins, replace wooden boardwalk, and check elevation of staff gages inside and out. (Photos: Appendix B, Photos 11 & 12).

Photo 11, Structure No. 5, showing inlet side of structure.

Photo 12, Structure No. 5, showing outlet pipe and flapgate with missing boardwalk.

Item	Condition	Physical Damage	Corrosion	Photo #	Observations and Remarks
Steel Bulkhead / Caps	N/A				
Steel Grating	Good				
Stop Logs	Good				
Hardware	Poor		Yes	11	Corrosion on padlocks, need to be replaced.
Timber Piles	Good				
Timber Walkway	Poor			12	Replace missing boardwalk.
Timber Wales	Good				
Galv. Pile Caps	Poor		Yes	11	Need to be replaced.
Cables	Good				
Signage / Supports	Good				
Staff Gages	Good				Check elevation of staff gages.
Rip Rap (fill)	N/A				
Earthen Embankment	Fair	Yes		11,12	Rock armor needed on both sides of structure.

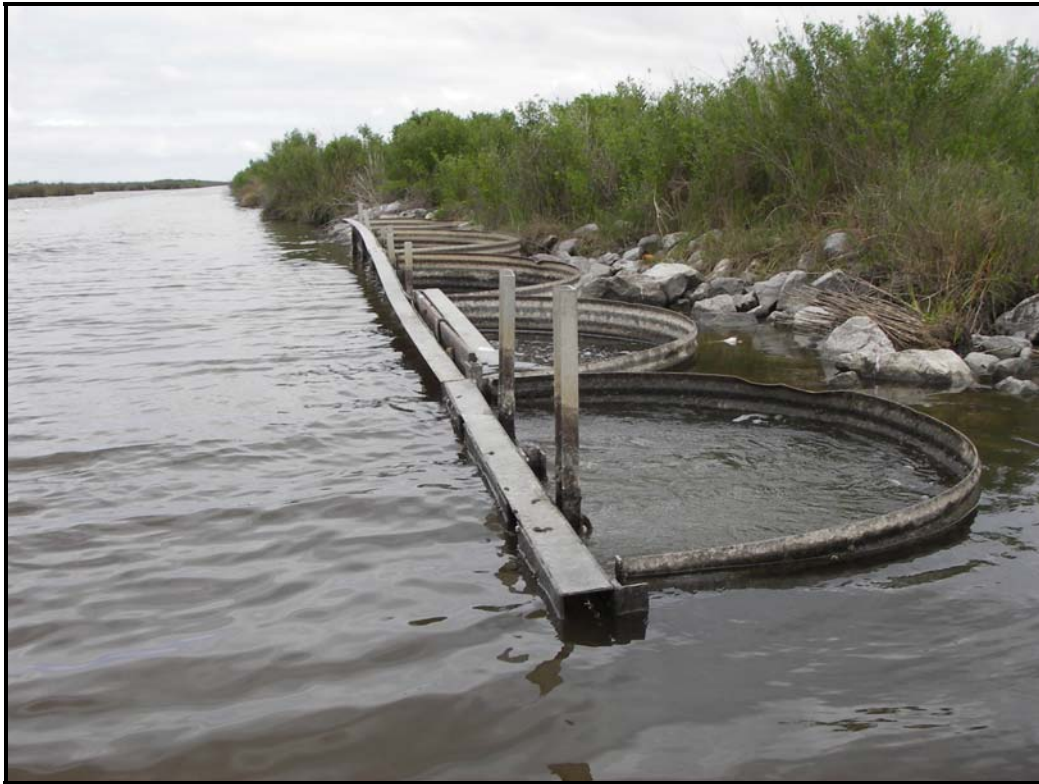
This structure is a pre-existing structure that was incorporated into the CS-20 Project. It is in disrepair and needs to be replaced. A new structure was let out for bids on February 10, 2005, however it was over budget and the bid was rejected. This structure will be replaced with a structure similar to ES-13, and the existing structure will be abandoned in place. Staff gauge readings were not available. (Photos: Appendix B, Photo 13).

Photo 13, Structure No. 4, view looking north.

Item	Condition	Physical Damage	Corrosion	Photo #	Observations and Remarks
Steel Bulkhead / Caps	N/A			13	GENERAL NOTE: Due to severe settlement of the overall structure, it is beyond repair and needs to be abandoned in place, and a new structure built along side.
Steel Grating	Poor				
Stop Logs	Fair				
Hardware	Fair				
Timber Piles	Poor				
Timber Wales	Poor				
Galv. Pile Caps	Good				
Cables	N/A				
Signage /Supports	Good				
Rip Rap (fill)	Fair				
Earthen Embankment	Fair	Yes

- ES-4 – replace structure, abandon existing structure in place.
- ES-3 – rock rip rap for bank erosion, clean out culvert, replace boardwalks, replace padlocks and check elevation of staff gages.

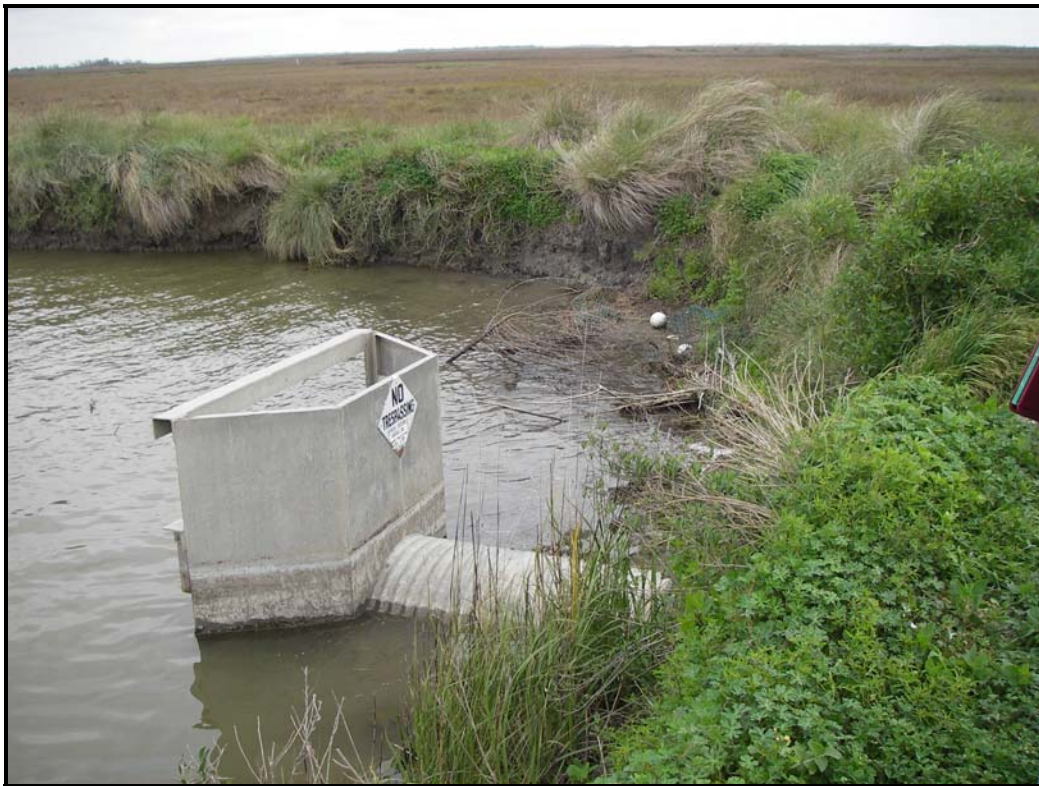
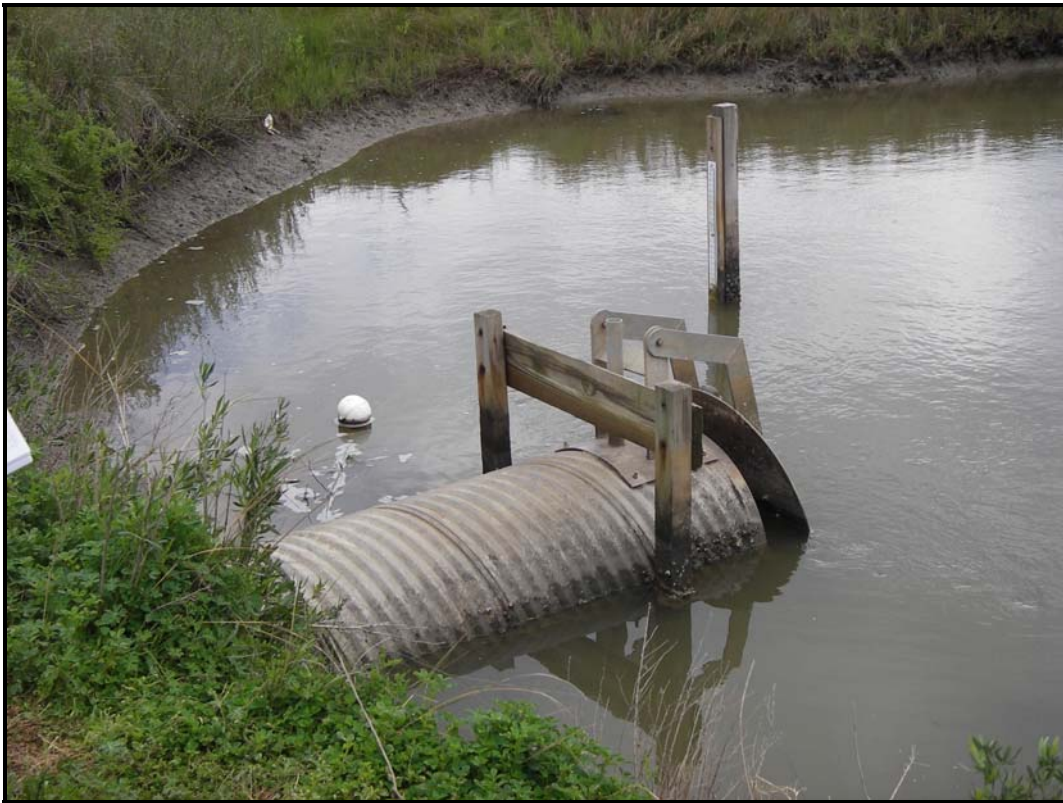
This is also a pre-existing structure that was incorporated into the CS-20 Project. The wooden walkways on the outside and the inside of the structure are missing. The structure is silted up with marsh debris. The bank, however, is showing signs of some erosion and will require approximately 209 tons of man-size rip rap for reinforcement. Water level on the outside staff gage was +0.6 NAVD88 and the gage on the inside was +0.95 NAVD88. (Note: these staff gages were recently replaced through the CRMS program). Water was flowing out to the exterior marsh. The padlocks on the stop log locking devices have rusted and cannot be operated. LDNR and NRCS agree that maintenance work is required to add rip rap, clean out debris, replace both walkways, replace padlocks, replace lock pins and check elevation of staff gages inside and out. (Photos: Appendix B, Photos 14 & 15).

Photo 14, Structure No. 3, showing erosion and missing boardwalk.

Photo 15, Structure No. 3, showing outlet pipe and flapgate.

Item	Condition	Physical Damage	Corrosion	Photo #	Observations and Remarks
Steel Bulkhead / Caps	N/A				
Steel Grating	Good				
Stop Logs	Good				
Hardware	Poor		Yes	14	Corrosion on padlocks, need to be replaced.
Timber Piles/ Walkway	Poor			15	Walkways on the inside and outside of the structure are missing.
Timber Wales	Good				
Galv. Pile Caps	Poor		Yes	14	Need to be replaced.
Cables	Good				
Signage / Supports	Fair				
Staff Gages	Good				Check elevation of staff gage on inside and outside of the structure.
Rip Rap (fill)	N/A				
Earthen Embankment Channel	Fair	Yes		14,15	Rock armor needed both sides of structure
	Poor			14	Inlet side of the structure is silted up with marsh debris.

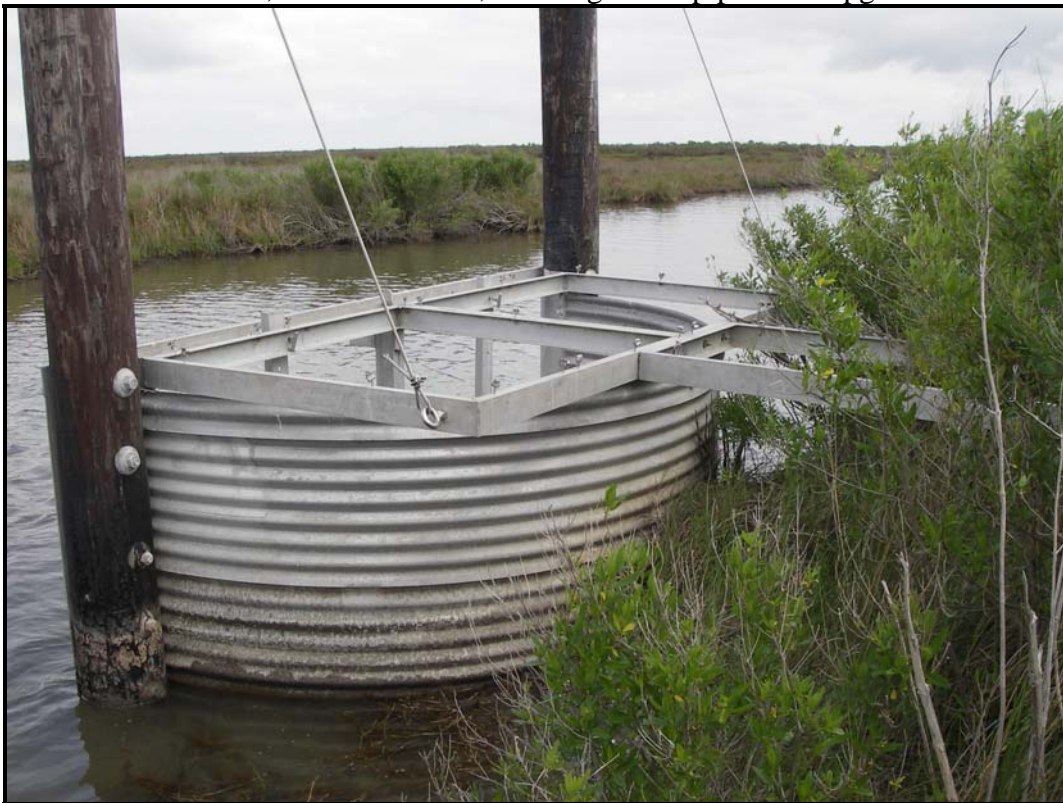
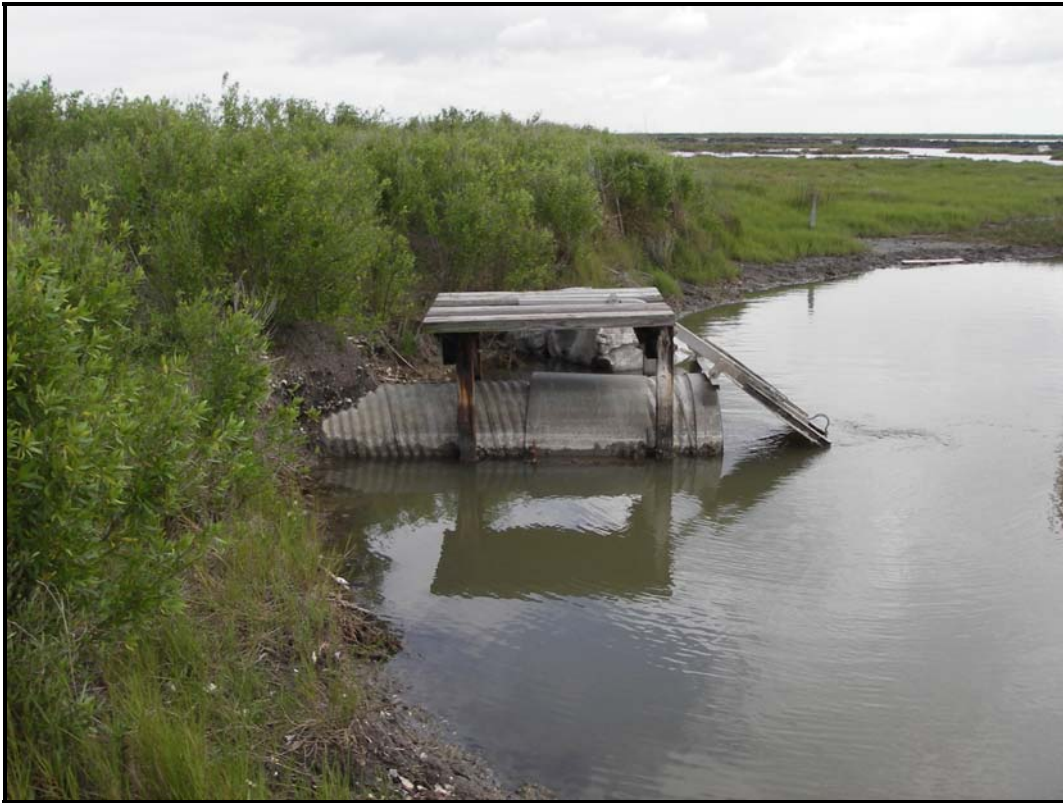
Vandals have stolen all of the grating on the inlet side of the structure. The structure is silted up with marsh debris. The bank, however, is showing signs of some erosion and will require approximately 470 tons of man-size rip rap for reinforcement. Water level on the outside staff gage was +0.8 NAVD88 and the gage on the inside was +0.9 NAVD88. (Note: these staff gages were recently replaced through the CRMS program). Water was flowing out to the exterior marsh. The padlocks on the stop log locking devices have rusted and cannot be operated. The metal pile cap covers have rusted out. The wooden boardwalk needs to be extended. LDNR and NRCS agree that maintenance work is required to add rip rap, clean out debris, extend the boardwalk, replace metal pile caps, replace grating, replace lock pins, replace padlocks, and check elevation of staff gages inside and out. (Photo: Appendix B, Photos 16 & 17).

Photo 16, Structure No. 1, showing missing grating and erosion around structure.

Photo 17, Structure No. 1, showing outlet pipe flapgate and erosion around structure.

Item	Condition	Physical Damage	Corrosion	Photo #	Observations and Remarks
Steel Bulkhead / Caps	N/A				
Steel Grating	Fair			16	Replace all sections of grating that are missing.
Stop Logs	Good				
Hardware	Poor		Yes	16	Corrosion on padlocks, need to be replaced.
Timber Piles	Good				
Timber Walkway	Poor			17	Need to extend walkway.
Timber Wales	Good				
Galv. Pile Caps	Poor		Yes	16	Need to be replaced.
Cables	Good				
Signage / Supports	Good				
Staff Gages	Good				Need to check elevation of staff gages inside and out.
Rip Rap (fill)	N/A				
Earthen Embankment	Poor			16,17	Rock armor needed both sides of structure.

- ES-1 – rock rip rap for bank erosion, extend boardwalk, replace metal pile cap covers and padlocks, check elevation of staff gages.
- ES-17 – replace warning sign, replace pile cap on sheet pile wall, check elevation of staff gages, and replace metal pile cap covers, padlocks and locking tabs.

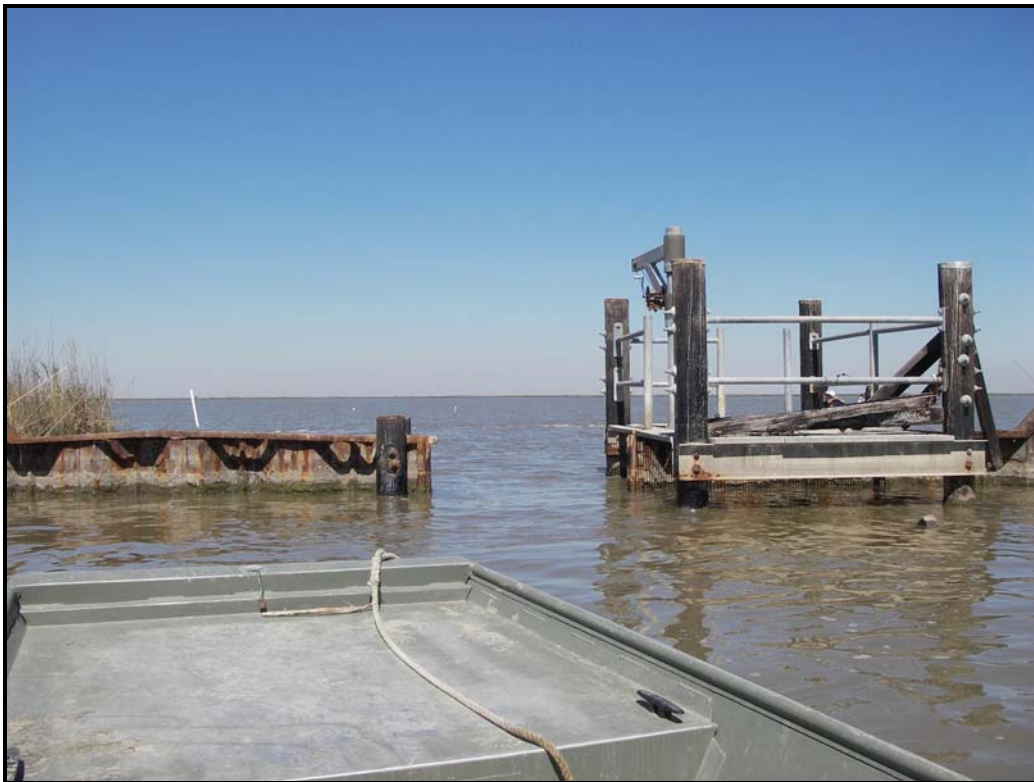
The sheet pile cap is severely rusted out on both sides of the structure. The locking tabs on the landing side of the stop log slots are missing. The warning sign is missing. The padlocks on the stop log locking devices have rusted and cannot be operated. The metal pile cap covers are rusted out. Water level on the outside staff gage was +1.0 NAVD88 and the gage on the lake side was +1.0 NAVD88. (Note: these staff gages were recently replaced through the CRMS program). Erosion is also occurring on each end of the sheet pile wall. LDNR and NRCS agree that maintenance work is required to replace sign and pile cap on sheet pile wall, check elevation of staff gages, replace metal pile cap covers, replace padlocks, and replace

Photo 18, Structure No. 17, view looking north.

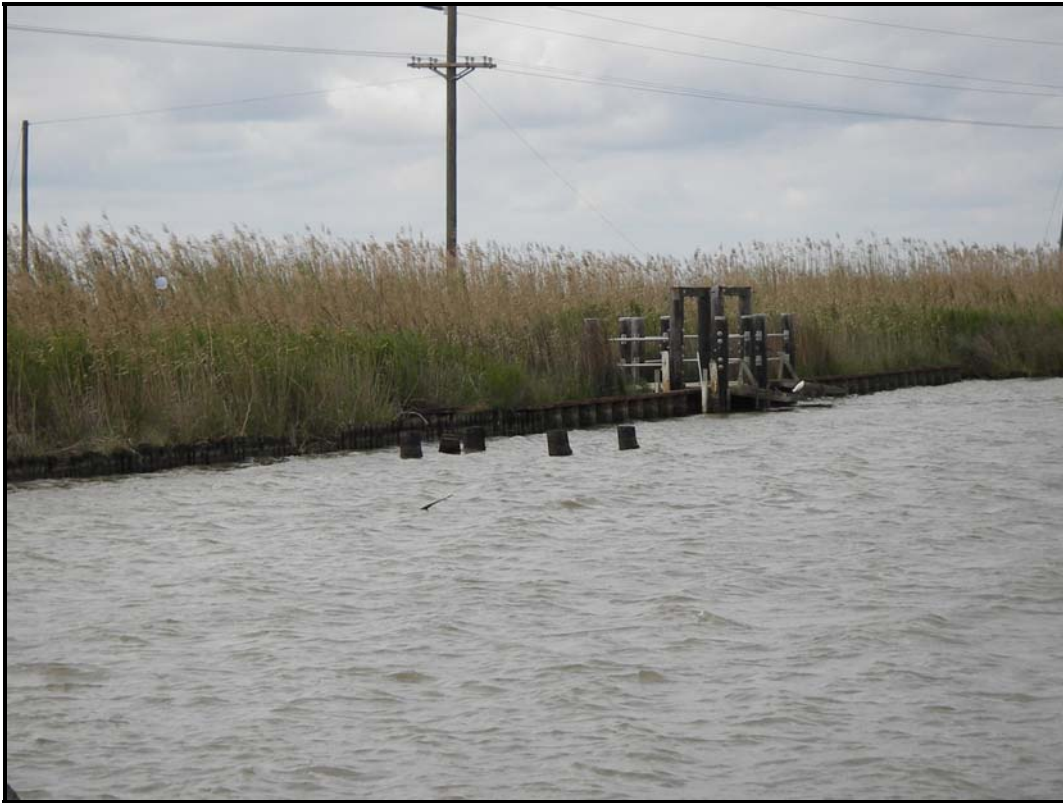
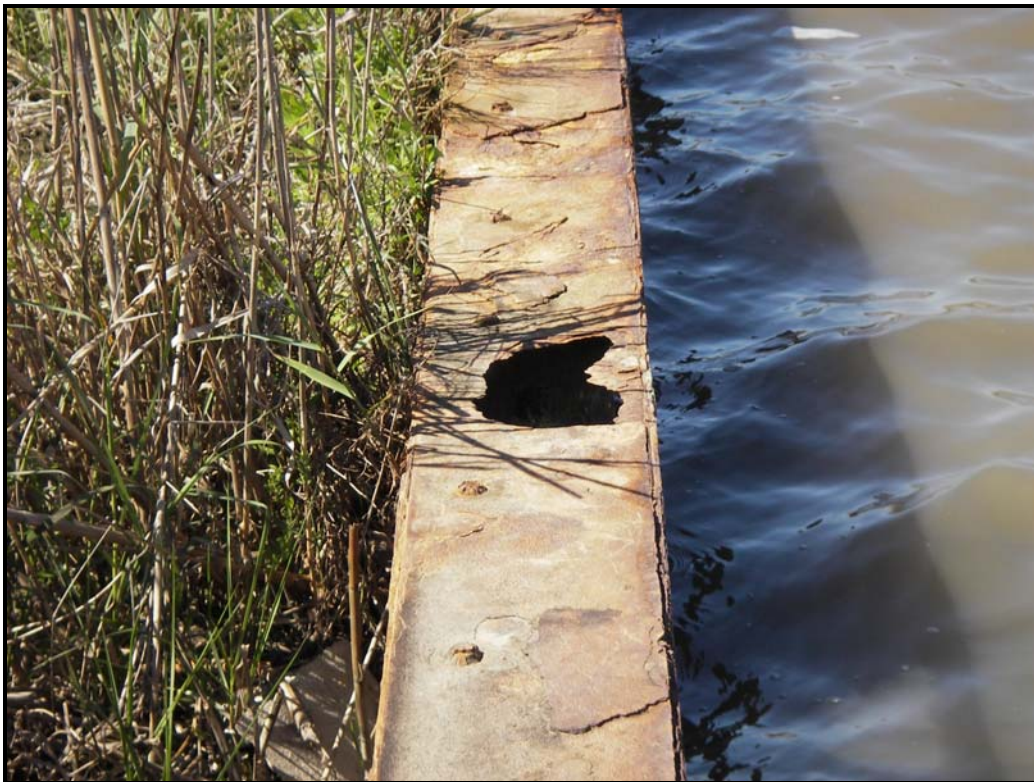
The warning sign is missing. Staff gages outside and inside were not readable. The structure is silted up with marsh debris. The padlocks on the stop log locking devices have rusted and cannot be operated. The metal pile cap covers have rusted out. The sheet pile cap on top of the sheet pile wall is severely rusted. Water was flowing into the interior marsh at the time of the inspection. LDNR and NRCS agree that maintenance is required to replace the warning sign, replace the metal pile cap covers, replace staff gages inside and out, clean out marsh debris, replace padlocks, replace locking pins, and replace sheet pile cap on both sides of structure. (Photos: Appendix B, Photos 19 & 20).

Photo 19, Structure No. 13, view looking northwest.

Photo 20, Structure No. 13, showing corrosion on sheet pile cap.

Item	Condition	Physical Damage	Corrosion	Photo #	Observations and Remarks
Steel Bulkhead / Caps	Poor		Yes	19,20	Some rusting of pile cap is present, needs to be replaced.
Steel Grating	Good				
Stop Logs	Good				
Hardware	Poor		Yes	19	Padlocks corroded, need to be replaced.
Timber Piles	Good				
Timber Wales	Good				
Galv. Pile Caps	Poor			19	Need to be replaced.
Cables					
Signage / Supports	Poor			19	Warning sign is missing, needs to be replaced.
Staff Gage	Poor			19	Staff gages need to be replaced inside and out.
Rip Rap (fill)	N/A				
Earthen Embankment	Good

- ES-13 – replace warning sign, replace metal pile cap covers, replace staff gages, clean out debris, replace padlocks, replace metal pile cap on sheet pile wall.
